**LAKE MOUNT UNION DAM**

NDS ID NO. PA-473

PHASE I INSPECTION REPORT  
NATIONAL DAM INSPECTION PROGRAM

**L. ROBERT KIMBALL & ASSOCIATES** ✓

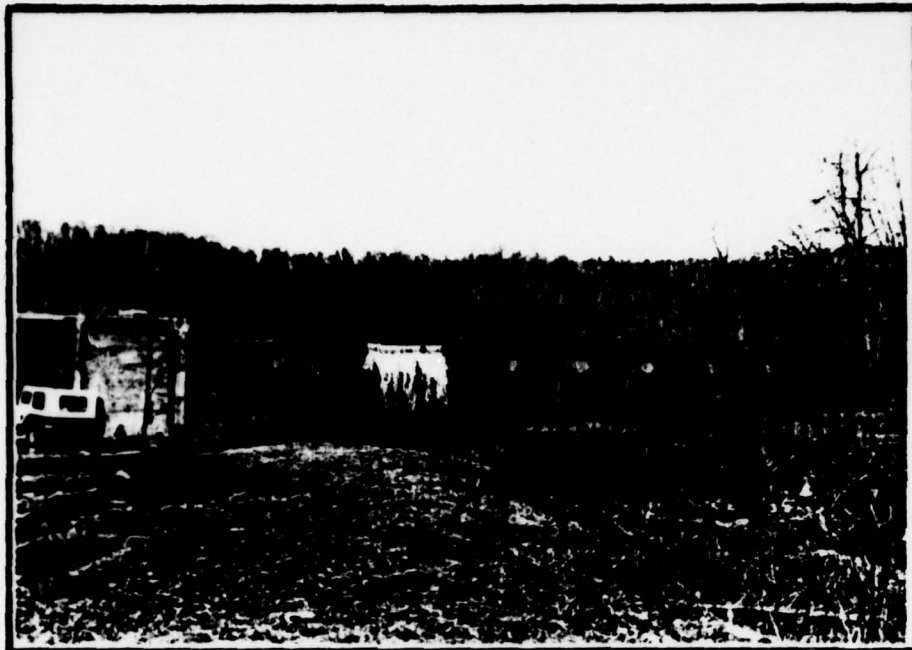
Overview of dam from downstream.

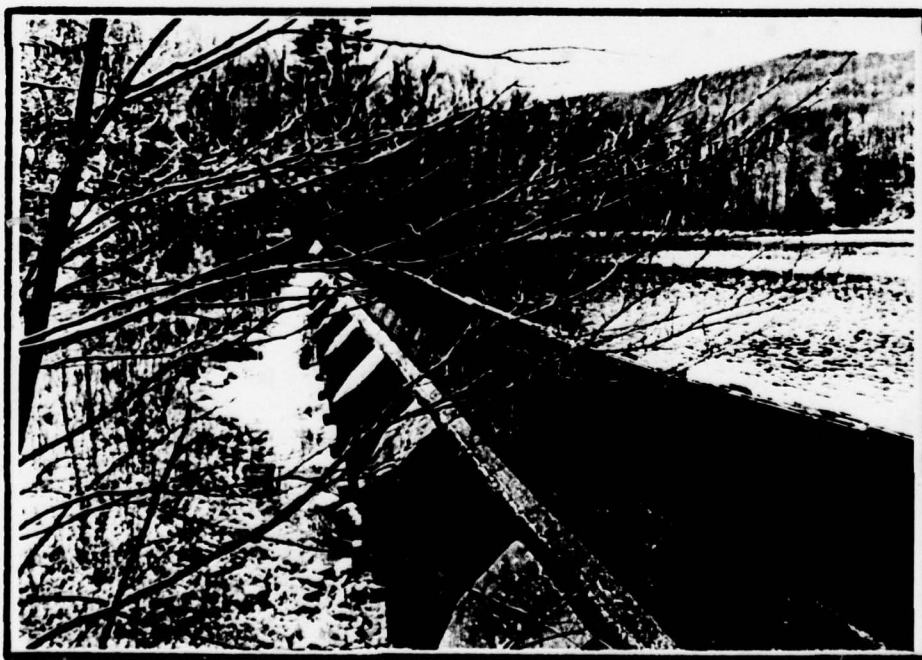
View of spillway crest from left abutment.

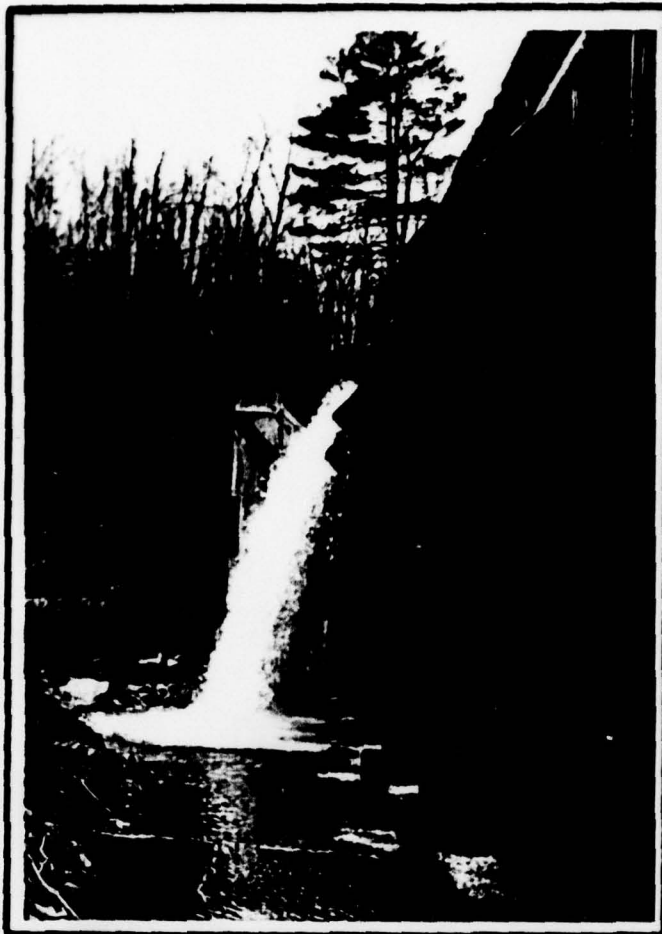
Downstream view of buttresses looking toward  
right abutment.

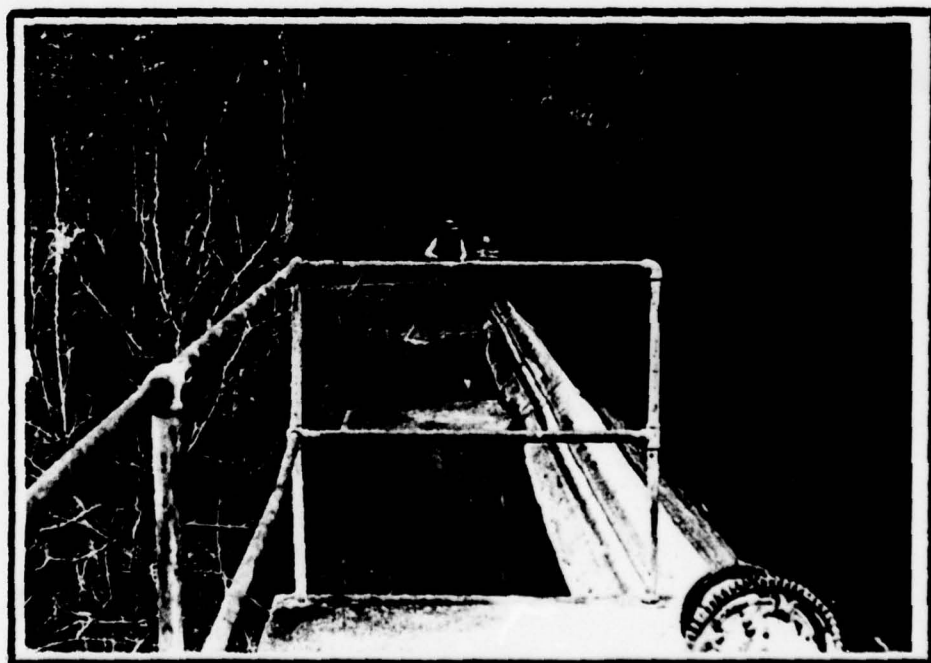
View of right abutment and non-overflow section.  
C-2

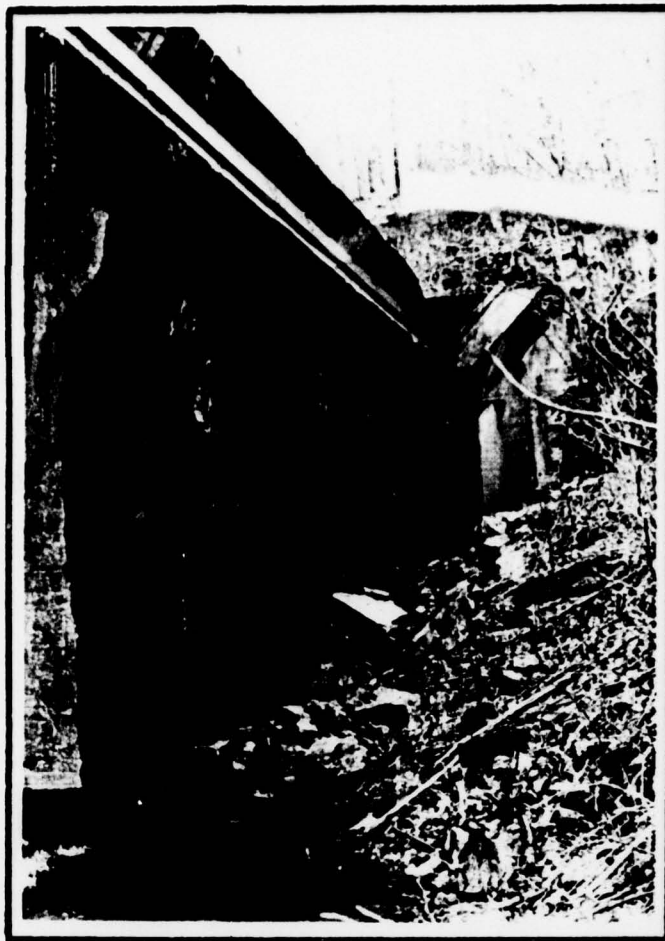
b. Dam. Visual inspection of the dam indicated the structure was in good condition. In general, the concrete in the dam appeared to be in good condition. Excess waste material from the foundation excavation has been placed beyond the toe of the dam. This waste material has trapped water between the waste material and the upstream slab of the dam. Detailed examination of the structure follows:

Downstream view of buttress looking toward  
left abutment. Note: waste rock downstream  
of buttresses.

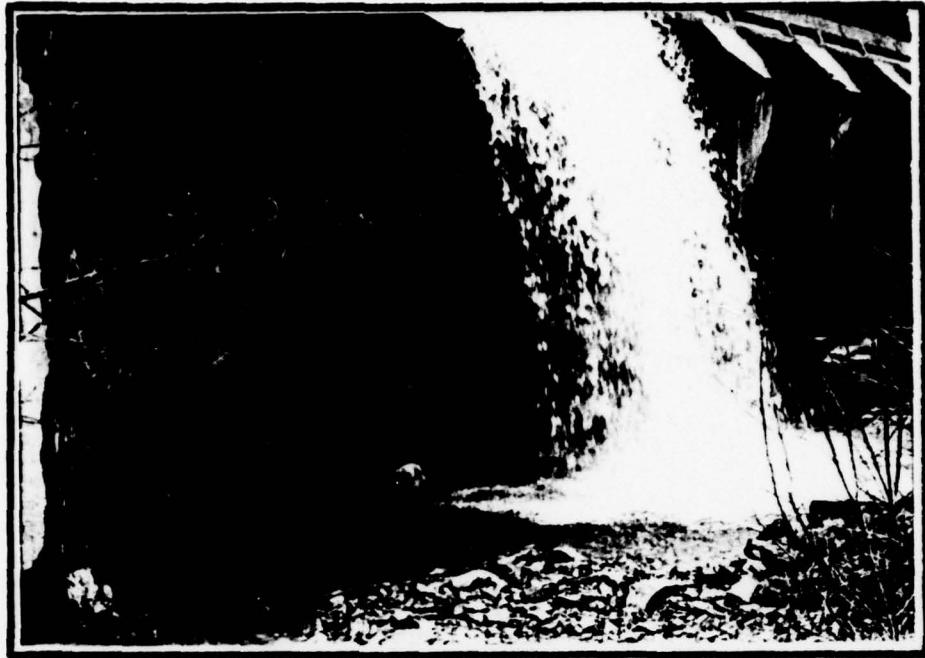
c. Visual Observations. The concrete in the spillway area appeared to be good condition. All the flashboards have bent or have partially failed. Discharge through the spillway is currently confined to where the flashboards have failed between buttresses 7 and 8.

Water flowing over spillway between buttresses 7 and 8.  
Note: deterioration of concrete buttresses.

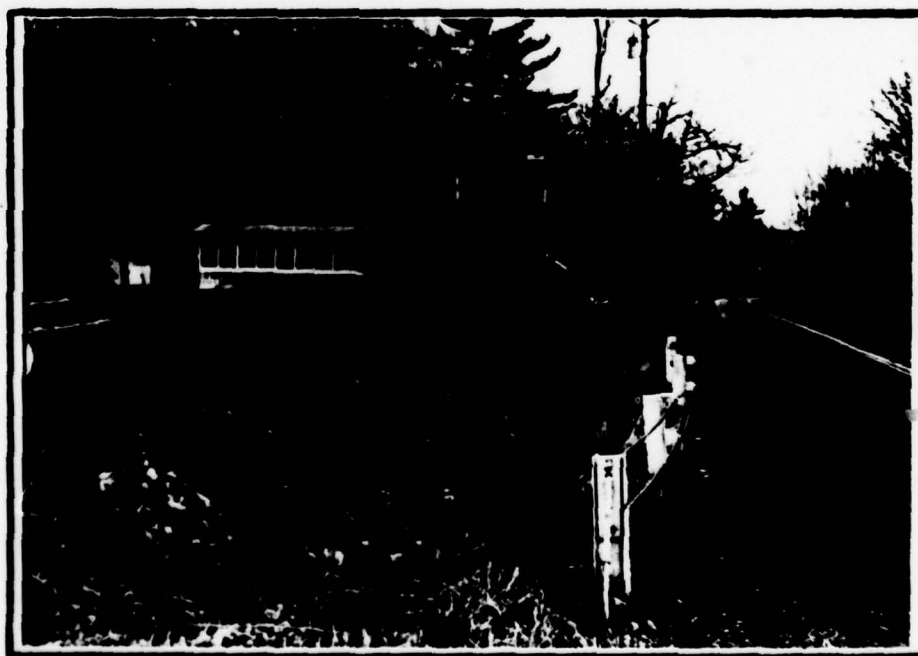
VISUAL EXAMINATION OF	OBSERVATIONS	REMARKS OR RECOMMENDATIONS
CONDITION (OBSTRUCTIONS, DEBRIS, ETC.)	Very narrow and confined for the first three quarters of a mile. No homes located within this stretch.	
SLOPES	Steep to moderate.	
APPROXIMATE NO. OF HOMES AND POPULATION	Within three miles, approximately 10 homes and 1 church (approximately 40+ people).

Several homes adjacent to stream.

3. A warning system should be instituted to warn downstream residences of high spillway discharges and during periods of heavy rainfall or high runoff, or failure of the dam.
